TAMIL NADU STATE BASELINE STUDY: TECHNICAL ASSESSMENT OF SANITATION CHAIN

January 2017

This document is produced as part of Tamil Nadu Urban Sanitation Support Programme (TNUSSP). TNUSSP supports the Government of Tamil Nadu (GoTN) and cities in making improvements along the entire urban sanitation chain. The TNUSSP is being implemented by a consortium of organisations led by the Indian Institute for Human Settlements (IIHS), in association with CDD Society, Gramalaya, and Keystone Foundation.

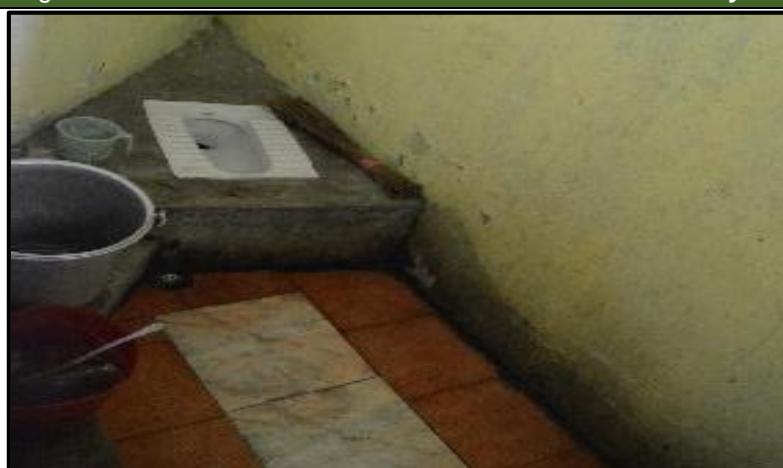
Figure 1.10: User interface in one of the household in hilly zone

Superstructure of the toilets in all the zones has walls mainly made of bricks (95 per cent) and few with tin/metal/AC sheets, RCC, bamboo/wood, and stone/cement mortar. The roofing materials used were either RCC slab (65 per cent) or tin/metal/AC sheets (27 per cent), while few had brick, bamboo/wood, and stone/cement mortar. Majority of the households had a pour flush system, while about a third had cistern flush. Indian toilet was the commonly reported toilet type (86 per cent) while the rest reported western toilet.

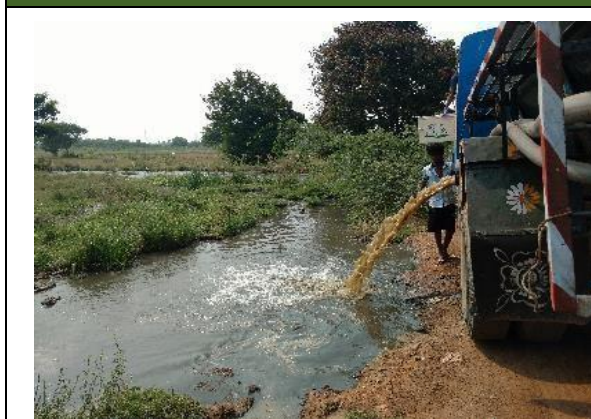
Figure A4.2: Disposal of Sludge into a Low Lying Water Body

intervals. Remaining 71 households were never de-sludged. Only three out of 90 households were following a desludging frequency of once in two years. Figure A4.2 shows a common disposal point of the town.

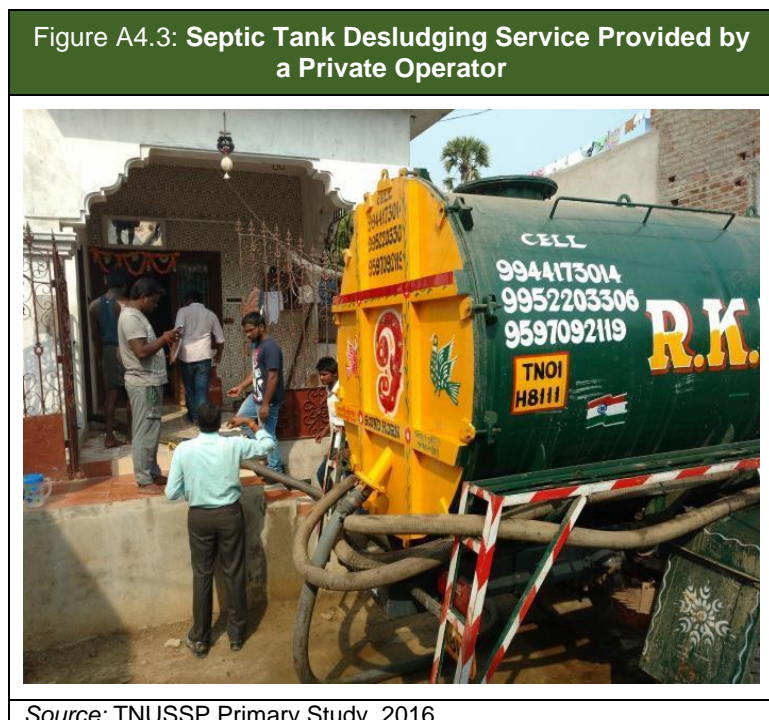
Septic tanks being de-sludged had a capacity of 4,500 – 5,000 litres and the service providers cover distances between 10 and 40 km to reach their clients as shown in Figure A4.3. Sludge is pumped out with a vacuum pump with horsepower of 10 – 20, manufactured at different locations in Tamil Nadu between 2004 and 2015. This process took about 3 – 8 min during field observations. Oil engines are the input power source in most cases, while two operators used engine shafts. Hosepipes are usually 33 – 50 m long and in one case only 7.6 m, while the diameter was four inches. Pump wetted parts are made of cast iron and the sludge collection pipe of rubber. To connect an extension pipe, clamps were used. Four out of six operators said that the hosepipe would have a life span of five years, while the remaining two claimed it was shorter.

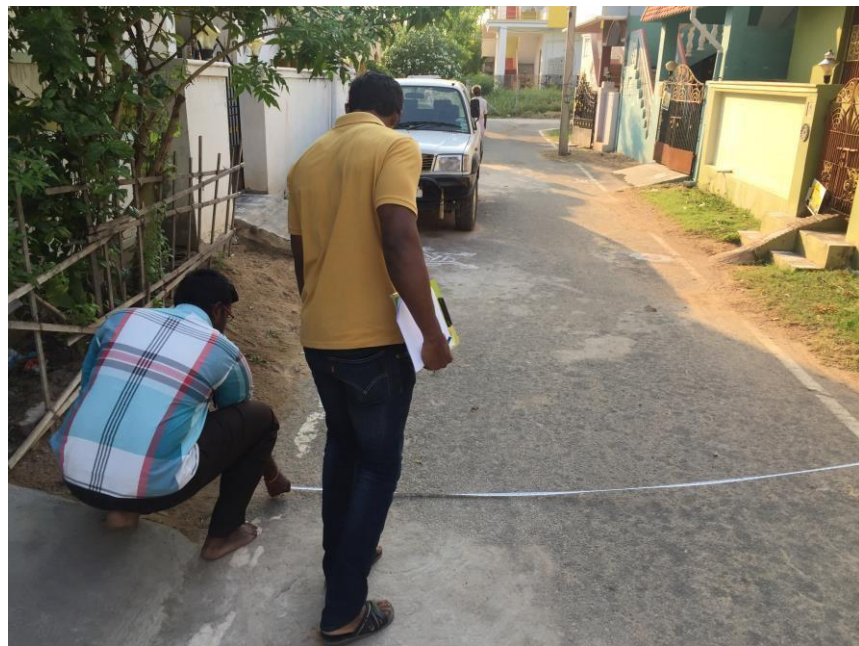
Figure A9.2: Measuring the Width of the Road to Observe the Truck Accessibility

Wider road access facilitates easy access to containment structures for desludging vehicles. In the sample, 211 households have a road width between 3 and 5 metres, while 202 households report a road width of 0-3 metres.
