## Improvement of sanitation at Kanawat health center Kanawat, Uganda

Case study of SuSanA projects

*Improvement of sanitation at Kanawat Health Center, Kanawa, Uganda*

SuSanA 2009

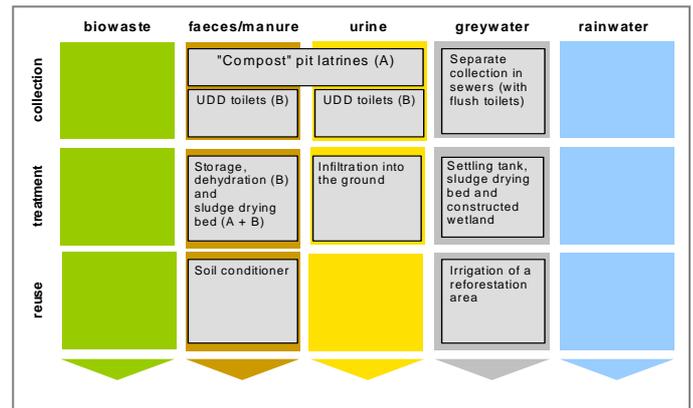
Fig. 2: Applied sanitation components in this project (A and B refer to two types of toilets used)

The project consists of following 6 main components:

1. The 6 old pit latrines for the patients were reconstructed as pit latrines that can be emptied (without urine separation, for details see section 6), hereinafter referred to as "compost" pit latrines (however, the term "compost" is misleading because in fact there is no composting process taking place here). This decision was due to the following reasons:

2. A urine diversion dehydration (UDD) toilet block with 4 cubicles was constructed for the staff in order to avoid problems related to conventional latrines and to demonstrate modern technologies. The staff was regarded as able to modify their user behavior according to the demands of such a toilet system, which they did. The toilets are equipped with urine diversion squatting pans produced by Cress tank in Uganda (for details see section 14).

3. Renovation of showers and laundry washing place, connection to a sewer system in order to avoid mosquito breeding and groundwater pollution.
4. A PVC sewer was built in order to collect the remaining wastewater from the Health Center's flush toilets, showers and laundry washing place.

5. The sewer drains into a wastewater treatment system consisting of a settling tank, a sludge drying bed and a horizontal subsurface constructed wetland for secondary treatment of the settling tank's outflow. When reaching a certain level (ideally every 3 months, realistically once a year), the sludge from the settling tank is stirred and discharged by gravity via a pipe into the drying bed.

6. This treated wastewater is collected in a concrete tank to be reused as irrigation water (see section 7). The water tank is designed to store the maximum daily wastewater flow which was estimated to be 5 m<sup>3</sup>. Surplus water overflows to a subsurface percolation trench irrigating tree plantations.

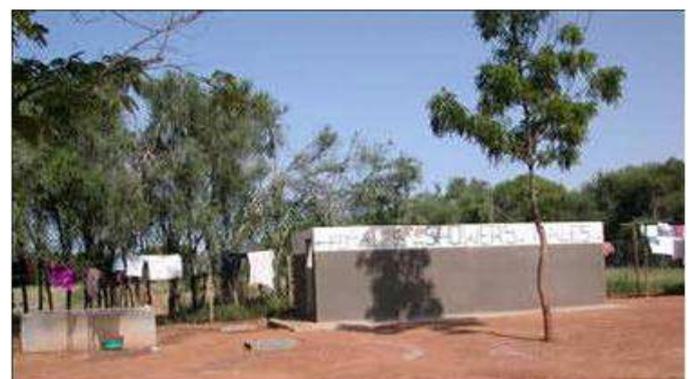
Fig. 3: Shower and laundry washing area of the Health Center (source: EcoSan Club, 2004)

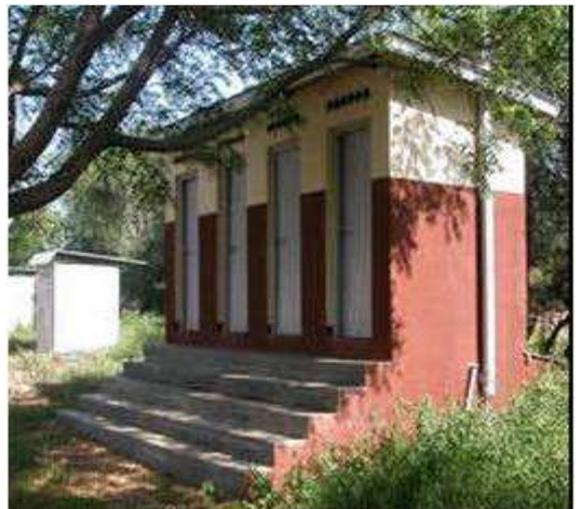
**Fig. 4:** New UDD toilet block with 4 cubicles for the staff (source: EcoSan Club, 2004)

The UDD toilet vaults can be emptied from the backside. Each toilet consists of an elevated concrete floor including a sealed plastic squatting pan (produced by Cress tank, Uganda). Ash is added after each defecation in order to absorb the moisture of the faeces and to raise the pH level so as to enhance pathogen destruction. The squatting pan leads faeces (together with anal cleansing material and ash) to a wooden basket located underneath in an above ground dehydration vault. These dehydration vaults are covered by metal sheets in order to benefit from solar heating. The baskets are emptied once a year and brought to an outside drying area for further dehydration. The drying area is situated close to the toilets in order to avoid long transport distances. After further drying the material is used as a soil conditioner.

Urine is infiltrated via a soak pit into the ground because its usage is not intended by the beneficiaries (see section 7). The soak pit is located next to the toilets.

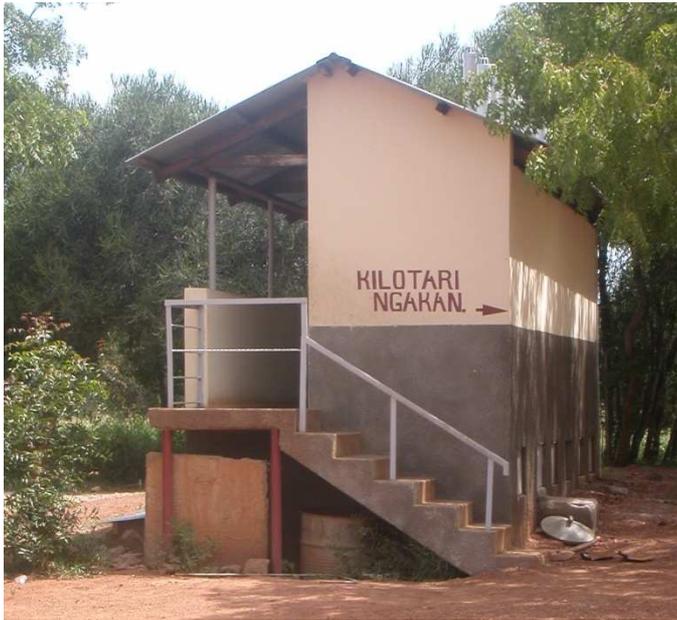
**Fig. 5:** New "compost" pit latrines for patients after reconstruction, side view (source: EcoSan Club, 2004)

The existing pit latrines were not significantly changed, only the vaults were renewed to support some composting to take place by providing emptying openings and a small extension with a metal cover for solar heating of the vault.

The bottom of the latrines has been sealed ex post with cement mortar. Liquids are discharged by a sewer into the constructed wetland and faecal material is emptied manually.

Experience has shown that the partly reconstructed pit latrines to so called "compost" pit latrines did not lead to satisfying results. Due to their poor design and subsequently difficult maintenance the "compost" pit latrines never worked properly.

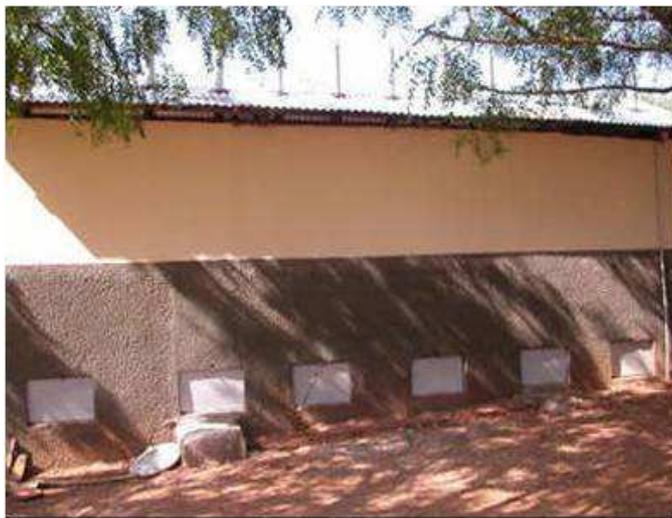
**Fig. 6:** New "compost" pit latrines for patients, rear view, showing access openings for the removal of faecal sludge (source: EcoSan Club, 2004)

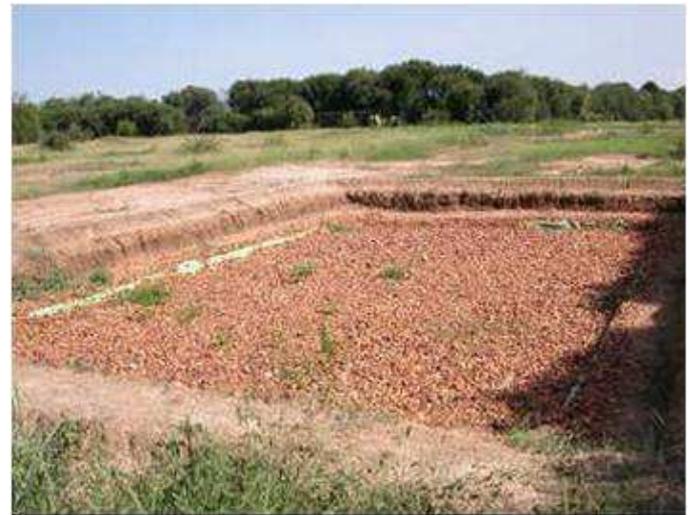
**Fig. 7:** Constructed wetland (5m x 9m) before greening in 2004 (source: EcoSan Club)

For the treatment of the remaining wastewater (some flush toilets and greywater) a horizontal subsurface flow constructed wetland system was built on an area of 45 m<sup>2</sup> growing indigenous non-fruit plants. Wastewater is pre-treated in a settling tank to remove solids (by sedimentation and flotation) before it flows by gravity to the inlet of the constructed wetland. The faecal sludge from the settling tank is regularly emptied (ideally every 3 months, realistically once a year) and the material is dried together with faecal material from the UDD toilets at the drying area.

The inlet of the constructed wetland comprises coarse aggregate (diameter of 60-80 mm) in order to distribute the wastewater horizontally before it enters the actual treatment part consisting of sand (diameter of 4-8 mm). The bottom of the filter bed has a slope of 1%. At its lower end another area of coarse aggregate including a drain pipe (PVC DN 100) collects the purified wastewater which is piped via an outlet manhole to an underground percolation ditch in the nearby reforestation area (10m of drain pipe DN 100 in a layer of coarse aggregate and covered with excavated material and soil).

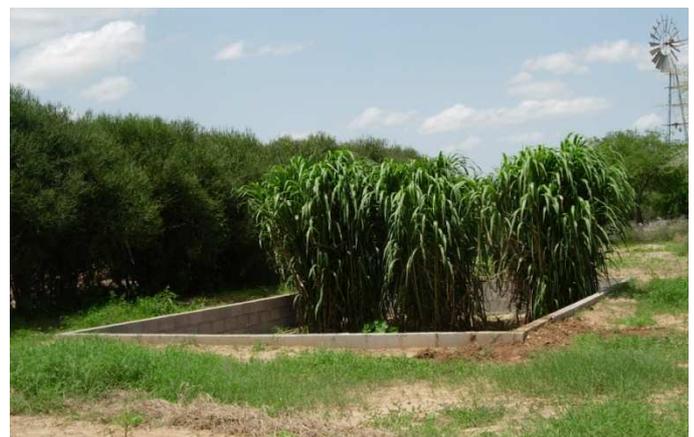
**Fig. 8:** Constructed wetland in 2006 (source: EcoSan Club)

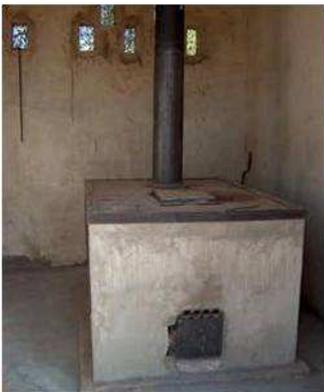
**Fig. 9:** Medical waste incinerator constructed on the Health Center's compound, 2004 (source: EcoSan Club)

A low cost medical waste incinerator based on a project of the Applied Sciences Faculty of De Montfort University in Leicester was constructed. Burnt residues are disposed in a covered and fenced dumping area, built on request of the project owner.
