Characterisation of Pit Sludge Management, Sludge Biochemical Degradation, and Respective Impacts on Public Health in Unplanned Settlements of Malawi

SRFA Project Study Sites

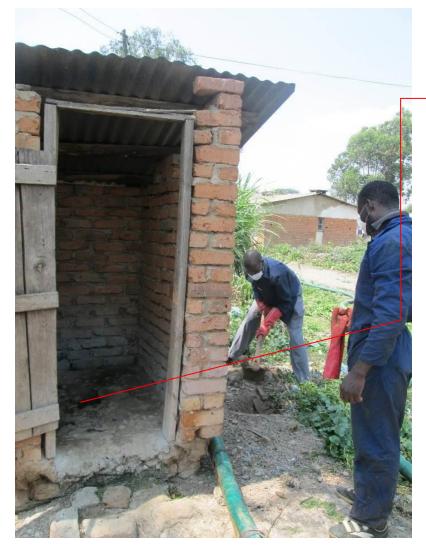
Sampling at different depths through the drop hole in a confined space

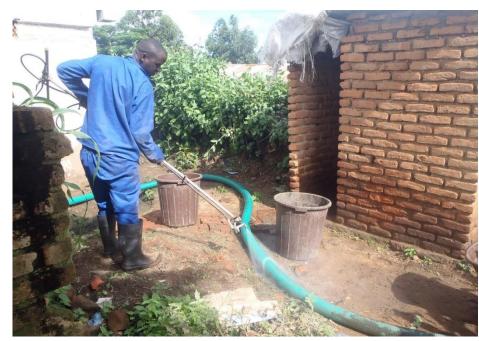
- Use of chlorine
- Fluidisation
- Fishing out of non-faecal matter before emptying

Water jet employed for cleaning also utilised for agitating hard sludge

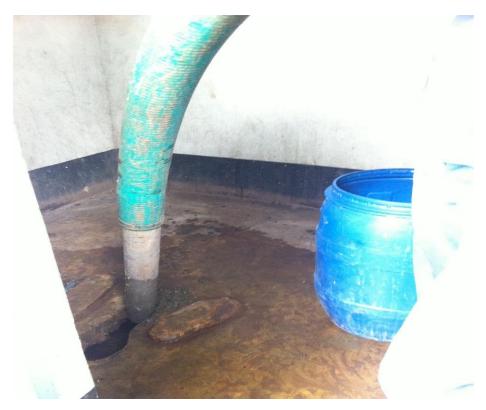
Unlined latrines avoided as they are susceptible to collapse after emptying

Desludging after excessive hydration due to presence of hard sludge

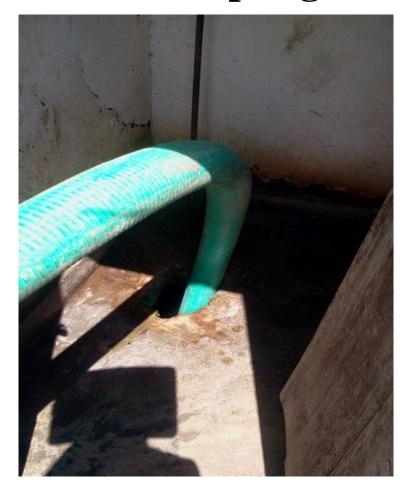
The sampling that worked

10 pits in Ntopwa (Unlined) 10 pits in Milare (Lined)

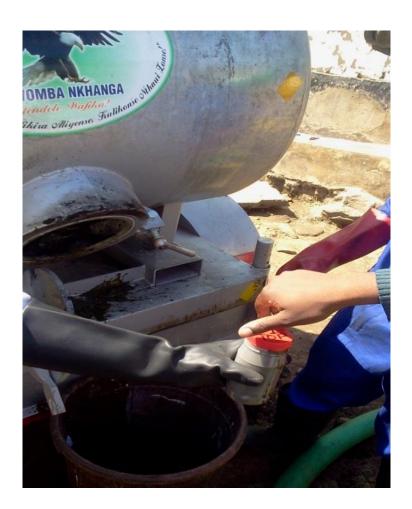
Motorised vacuum pump hired from Waste and Environmental Solutions (WES) a private company specialising in pit emptying.
