PUBLIC SANITATION FACILITIES IN TIRUPATI MUNICIPAL CORPORATION*

Needs Assessment

*This report has been prepared by the Centre for Development Finance, IFMR, Chennai for the Deutsche Gesellschaft für Internationale Zusammenarbeit (GIZ) under its new programme on "Advisory support to the National Urban Sanitation Policy" of the Ministry of Urban Development (MoUD), GoI

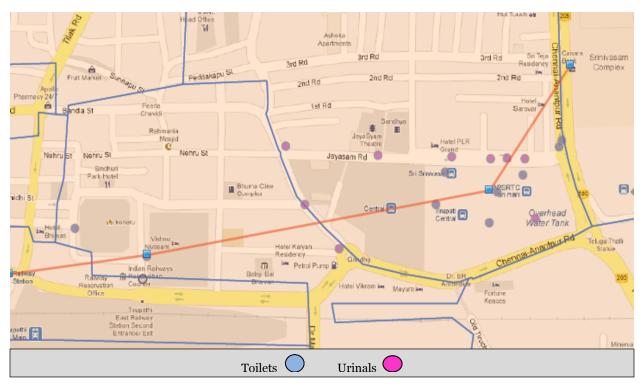
Figure 1 Tourist Corridor in TMC

Based on discussions with the TMC officials, the tourist corridor in the city was identified as an approximately 2 km road distance, spanning the city's Railway Station in Ward 14, Vishnuvasam Pilgrim Amenities Complex in Ward 14, the RTC Bus Stand in Ward 13 up to Srinivasam Pilgrim Amenities Complex in Ward 13.

The CSP identifies a daily floating population in the Tirupati city as 55,000 persons/day. According to the MoUD norm of 1 toilet seat per 250 floating population, the public sanitation requirement to cater to the daily floating population along the tourist corridor in Tirupati is 220 toilet seats. The existing supply along this corridor is 212 toilet seats (not including the 144 urinals catering to men and toilets located inside the Railway Station). User catchment appears to be particularly high near the Railway Station and in the RTC Bus Stand. It is also observed that the number of toilet seats for women (121 seats) is higher than that for men (91 seats) along this corridor. The current supply is 8 toilet seats short of the prescribed norm.

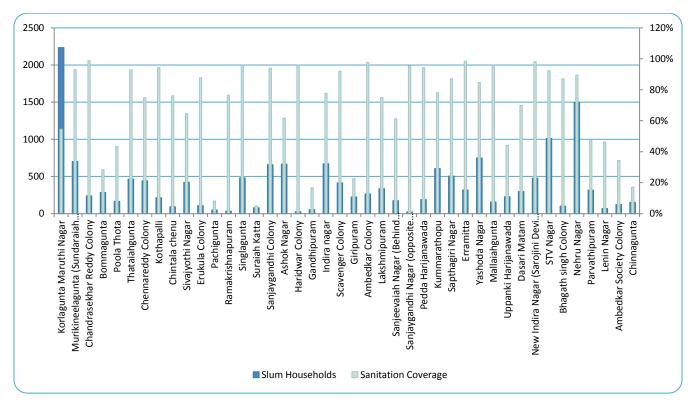
Figure 2 Sanitation coverage of Slum Households in TMC

TMC boasts of a high level of sanitation coverage at the household level across its slums (see Figure 1). Out of the 16308 slum households, 10773 households appear to have own toilets for their household use (66% coverage). These toilets appear to be of the pour-flush/flush variety and connected to septic tanks. Slum areas with more than 80% coverage of own toilets connected to a septic tank facility include: Sundaraiah Nagar, Chandrasekhar Reddy Colony Thataihgunta, Kothapalli, Scavenger Colony, Ambedkar Colony, Sanjaygandhi Nagar, Pedda Harijanawada, Sapthagiri Nagar, Yasodha Nagar, New Indira Nagar, STV Nagar, and Nehru Nagar. On the other hand, slums such as Bommagunta, Pachigunta, Ramakrishnapuram and Suraiah Katta record coverage of less than 10% of own toilets connected to septic tanks.

About 10% of total slum households in TMC (1608 households) have access to shared or community toilets which are of the flush variety and connected to septic tanks.

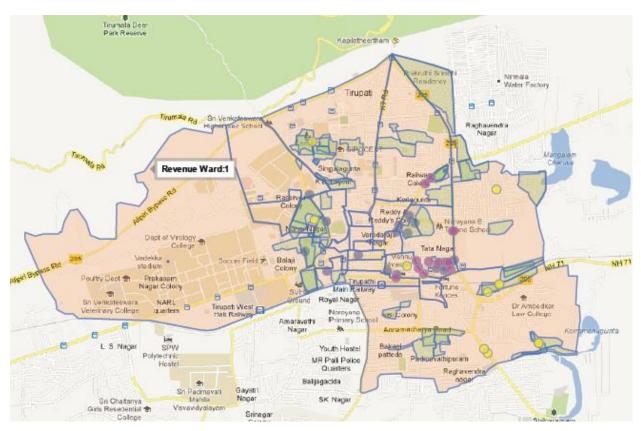
In terms of geographical spread, slums appear to be concentrated in specific wards and not evenly dispersed across the city, with high concentration in revenue wards 6, 19 and 20 (ward 6 has 8 slums, ward 19 has 9 slums, and ward 20 has 8 slums). However, there are no public toilets in wards 6 and 19. Ward 20 boasts of 9 public toilets, but these toilets are managed by TTD and are not accessible to the general public or slum populations in the city. Apart from ward 13, the remaining wards which house the slums in the city have access to only 1 public toilet block (wards 1, 4, and 17) per ward or no access to public sanitation facilities at all (wards 6, 18, 19, and 20). This state of affairs exhibits a clear disregard for recommended service norms on access to public sanitation (least 1 toilet seat for every 50 slum population).

For instance, the public toilets located in ward 13 are closest in terms of access to the 5 slums located in ward 18. The distance between the public toilet in ward 13 which is closest to the slum Suraiah Katta (located in ward 18) is about 1.2 km and the closest urinal (located within ward 18) is about 810 metres in distance. Similarly, the Pachigunta is a slum area located in ward 6. The closest public toilet to this slum is in ward 5, at a distance of approximately 1 km. In the case of Lenin Nagar and Parvathipuram, both slums located in ward 19, the closest public toilet in ward 13 is at a distance of 1.8km.
