SFD Lite Report

Thatta Pakistan

This SFD Lite Report was prepared by WaterAid Pakistan

Date of production/ last update: 01/10/2018

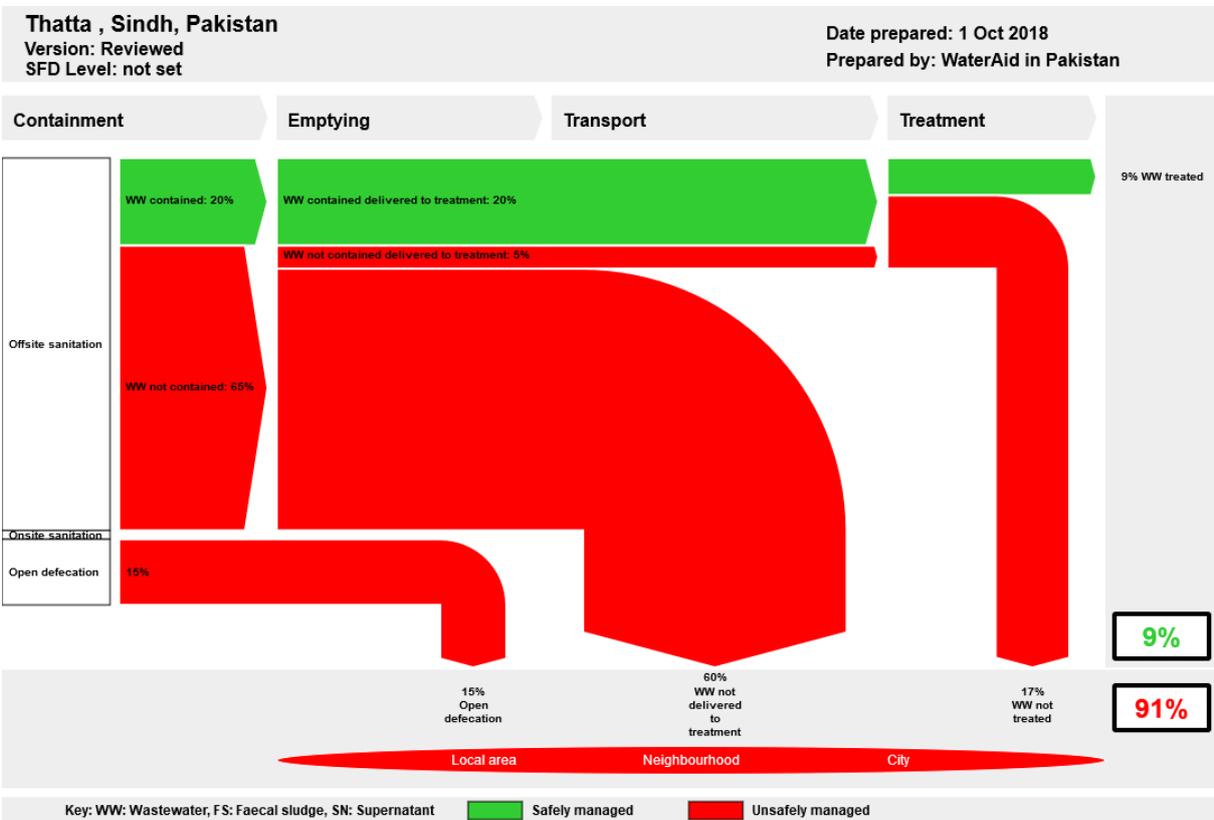
1 The SFD Graphic

Produced with support from the SFD Promotion Initiative with funding from the Bill & Melinda Gates Foundation. The SFD Promotion Initiative recommends that this graphic is read in conjunction with the city's SFD Report which is available at: sfd.susana.org

Although there is one treatment facility in the city, that too only treats nine percent of the total waste. (As seen in the SFD graphic). Currently there is no plan to build treatment plants or enhance the current treatment plant to standardise end-use and disposal.

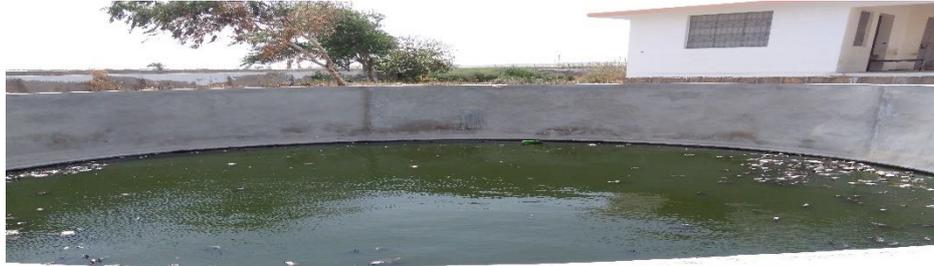
Figure 1: Treatment of wastewater in Thatta City

4.4 Treatment: The city has no faecal sludge treatment facility. Recently, the city administration constructed a sewage water treatment plant, which receives 20 percent of the city's sewage water (KII 1, 2018; KII 2, 2018; KII 3, 2018). However, due to frequent load shedding, the plant treats only nine percent of the sewage water it receives. The treated water is then disposed of into the irrigation system and is used on local farmland.

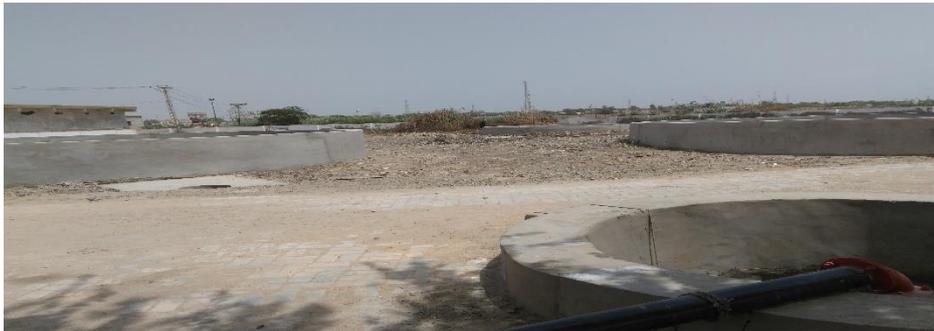
Figure 2: Wastewater treatment plant area

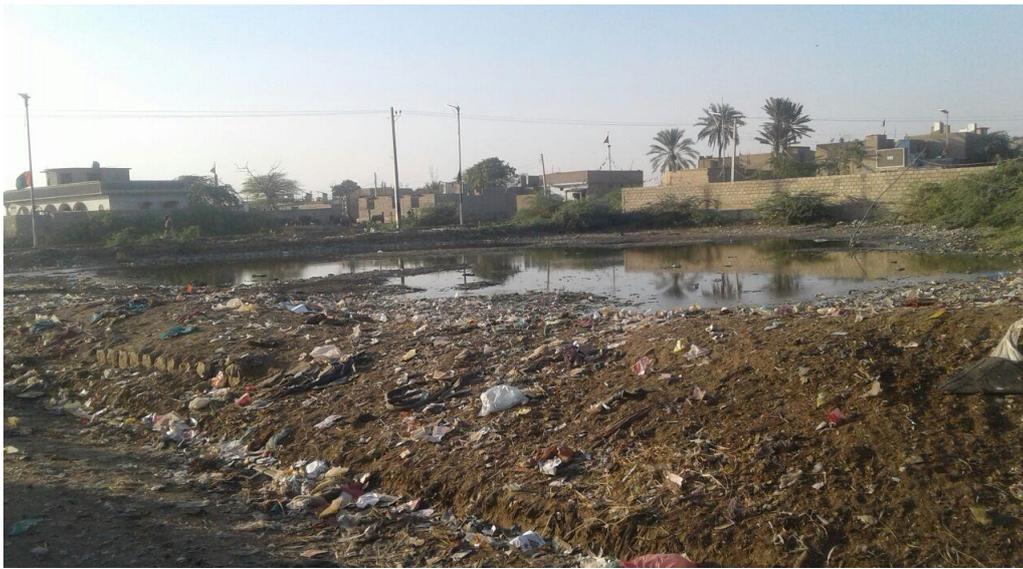
Figure 3: Sewage leaked on to open ground

Dumping of liquid waste on open ground is practiced by a small segment of the population of Thatta. Most of these are households that have connected their sewage pipes to the city's combined sewage pipes. When there is a blockage, residents make holes to release the blocked waste, and the waste gets into open areas. Although the Sindh Environment Protection Act & Pakistan Environment Protection Agency (PEPA) has stipulated penalties for those who release effluent into the environment but, due to poor capacity and lack of monitoring by the government agencies responsible for the sanitation/sewage system, this policy is not enforced. This is despite the SEPA 2014 has explicitly stipulated that action will be taken against government bodies that do not comply with the rules and regulations set by the environmental agency (SEPA, 2014).

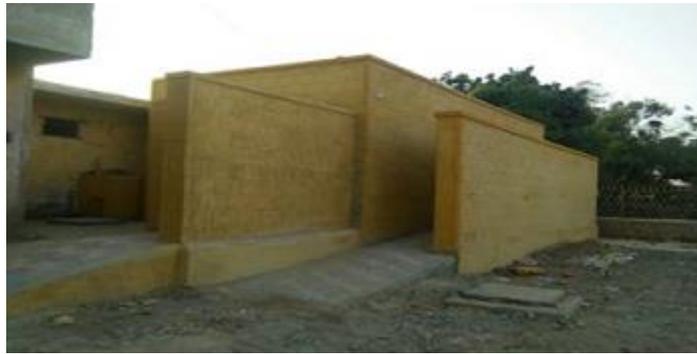
Figure 4: Public toilets built by WaterAid in Thatta city

Stakeholders' Engagement: With the help of its partners (National Rural Support Programme - NRSP, Municipal Committee, Water and Sanitation Agency - WASA) in Thatta, WaterAid is working on several projects such as a city-wide approach for improved WASH services in Thatta and has also built public toilets for the city's residents (see Figure 5). WaterAid also plans to work in other areas such as behavioural change to improve the quality of life of the people in Thatta.

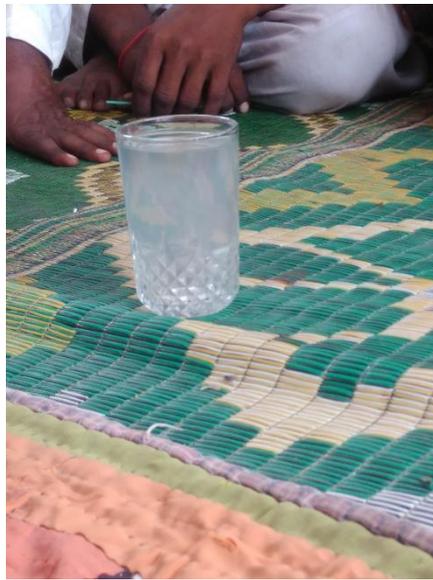
Figure 5: Image of drinking water supplied by the government.

Several tests have been conducted of the water quality in Thatta (Supply Water). Unfortunately, these test results show that the water provided by the government is not suitable for drinking, due to microbiological and chemical contamination and the water's physical properties, as shown in Table 2.
