KILAKARAI BASELINE STUDY FOR URBAN SANITATION

January 2019

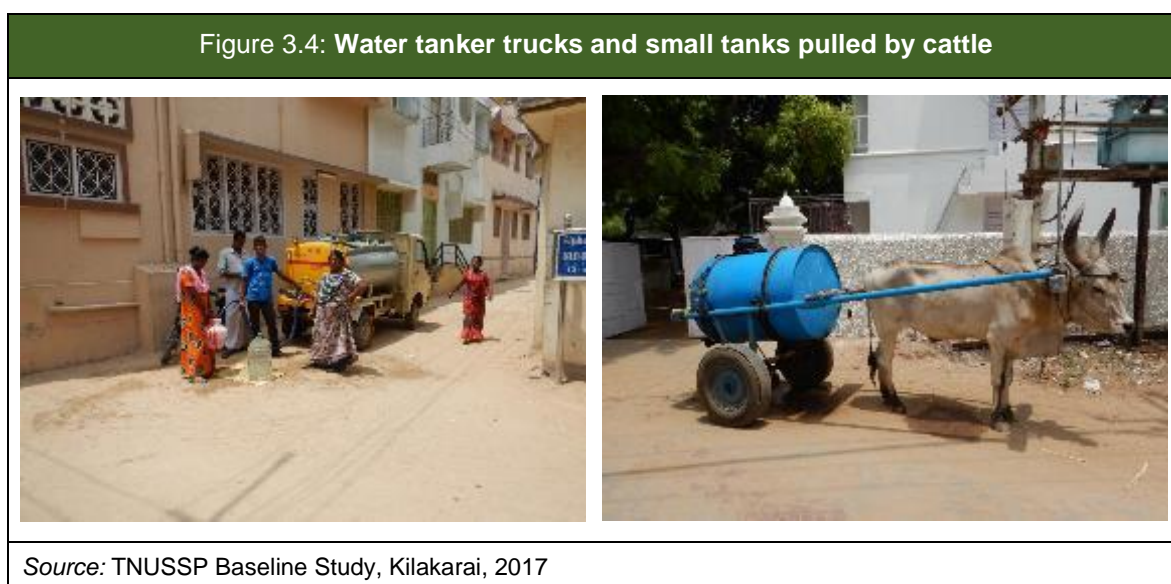
Interactions with households brought to light the current water shortage persistent in Kilakarai. With intermittent municipal water supply and increased salt content in ground water, households are forced to depend on private vendors for potable water. Water tanker trucks and small tanks pulled by cattle are a common sight in the municipality. Households pay between ₹7 and ₹10 for one pot of potable water. Having an own well within is also a dependable source of potable water for a few households.

The study data corroborated the above findings with 86.8 per cent households reporting their dependence on private water tankers/trucks for drinking and cooking purposes (potable). This practice is more prevalent among slum households (94.8 per cent). Over one-fourth or 30 per cent of the households depend on water sources within their dwelling such as own hand pump/tube well, own well that may be protected or unprotected for potable water. Bottled or can water is also a preferred source for 12.6 per cent households.

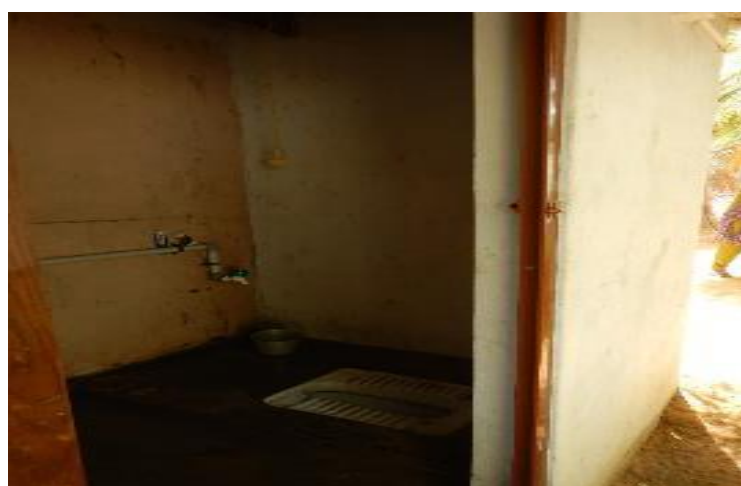
Figure 3.6: Individual household toilet

During the primary study, the team interacted with households in different parts of Kilakarai to understand the sanitation arrangements currently in place among households. It was generally observed that majority of the households have an independent toilet within their premises. The most common toilet type is the Indian style pour-flush latrine. Western closets are also used in high- and middle-income households.

In almost all households in slum and non-slum areas, the toilet facility is inside the house (98.4 per cent). This arrangement is observed to be more prevalent among households in non-slum areas. In few slum households (5.5 per cent), the toilet facility is located outside the house but attached to the house.

Irrespective of the location, the predominant material of the roof is reinforced cement concrete (RCC) for most of the toilets. This is followed by burnt brick/stone for facilities inside the house (7.2 per cent) and asbestos for toilet facilities outside the house but attached and outside the house but detached/ stand-alone (28.8 per cent and 31.0 per cent respectively). Tin/metal sheet is the predominant roof material for toilets in 20.7 per cent households that have the facility outside the house but detached/ stand-alone.

The predominant material of the wall is burnt brick/stone/concrete block for majority of the toilet facilities. Few toilets that were outside house but attached and outside the house but detached/stand-alone have walls made of tin/metal sheet.

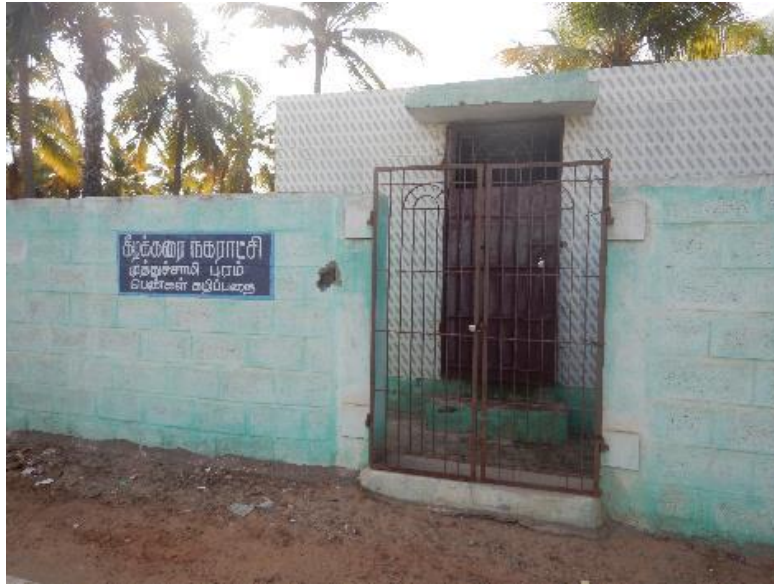
Figure 3.7: Public toilet in Muthuswamipuram, Kilakarai

As per the Kilakarai municipality records, there are five community toilets and one public toilet. Community toilet usage is reportedly low as a high proportion of households have an individual toilet within their premises. The community toilet in Muthuswamipuram is used by a few households who do have an individual toilet. Bathing facilities are also available within the toilet complex. The public toilet is located inside the bus stop.

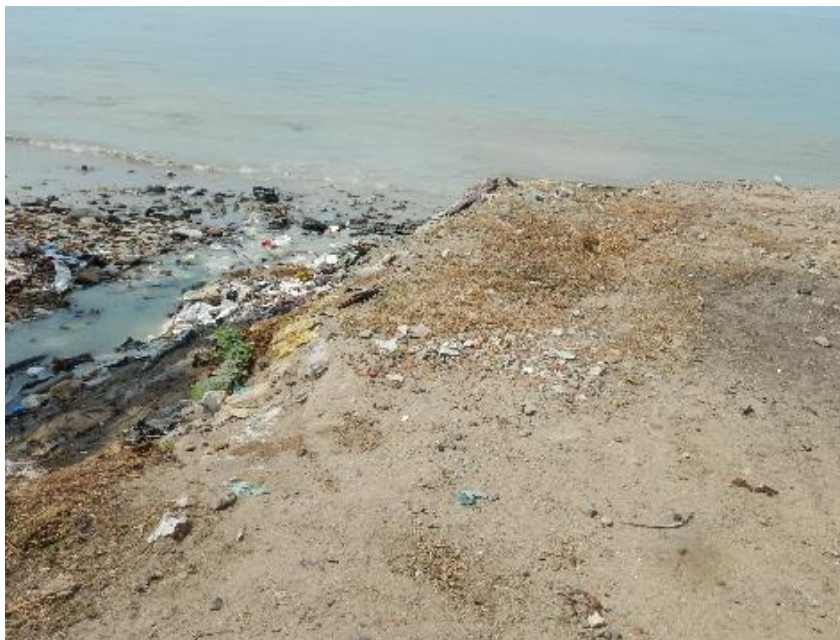
Figure 3.8: Open defecation site near the shore

Open defecation was reported in Meenavarkuppam. A few hutments have no toilet facilities and one possible site for open defecation is near the seashore.

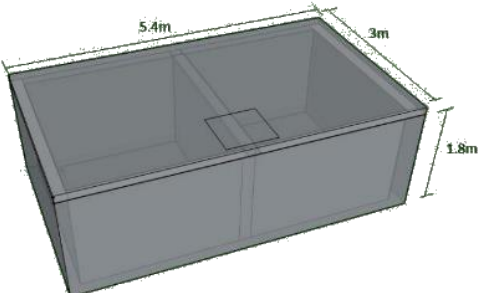
Type 1	Type 2

Figure 3.11: Illustration and description of type of OSS

<p>Dimension(LxBxD): 5.4m x 3m x 1.8m (approx.) Chambers: 2 (separated by baffle wall at the center with holes) Base: Non-Porous, Plain Cement Concrete (PCC) (a mixture of sand, cement and crushed stones). Walls: Non-Porous, Brick work Top Slab: RCC Access Cover (Y/N): Yes Soak Pit: No Other details: Mostly observed in public and community toilets, mosques, schools, hotels and bungalows Septic tank constructed with support walls made of brick and the base was made of PCC</p>

Interactions with masons and builders on the OSS system specifics revealed that most of the large residential buildings, schools, hotels, mosques and public and community toilets are connected to septic tanks. As presented in Table 4.10 – Type 1 these structures are almost in line with the WHO specifications with both the base and walls non-porous, plastered and two-chambered. However, at the household level, the OSS was mostly reported as a circular structure with pre-cast RCC rings. The base is porous with a depth of 3 m and diameter of 1.2 m.

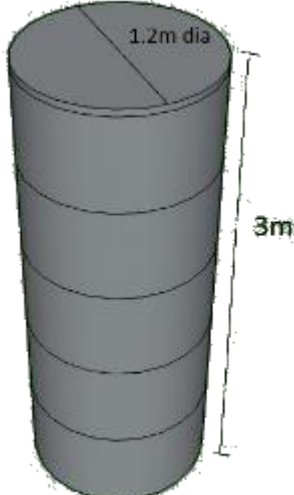
<p>Dimension: 3m depth and 1.2 diameter (approx.) Base: Porous Walls: RCC rings Top Slab: RCC Access Cover (Y/N): Yes Other details: Mostly observed in middle and low income households. The precast RCC rings are locally made</p>
<p>Source: TNUSSP Baseline Study, Kilakarai, 2017</p>

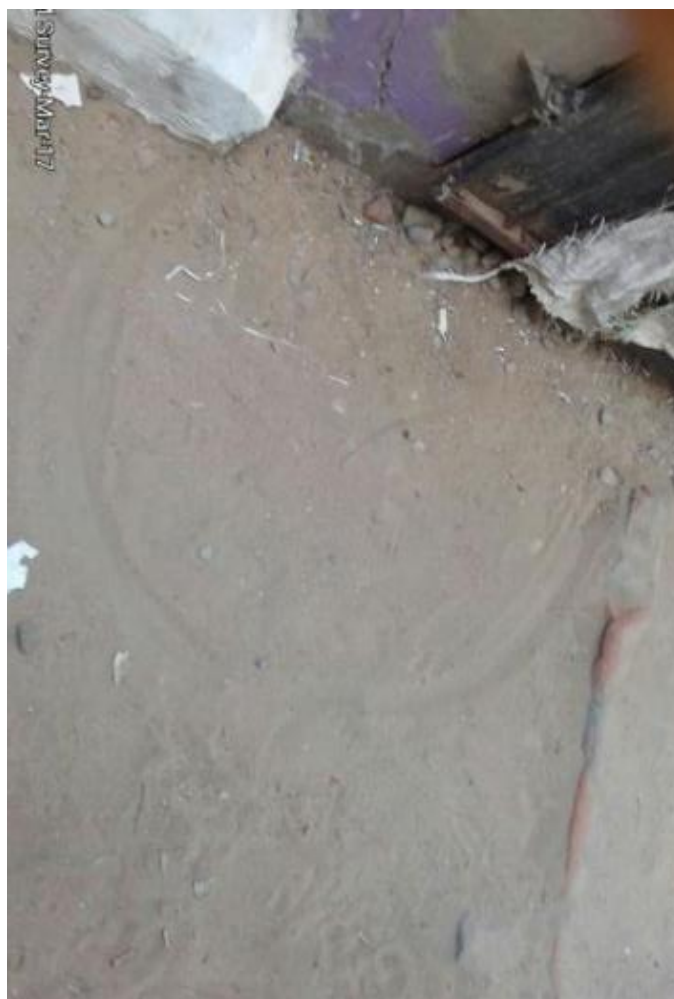
Figure 3.12: Location of a single pit

The containment system in almost all the households is single pit. These pits below ground level are sealed and need to be broken to access the system.

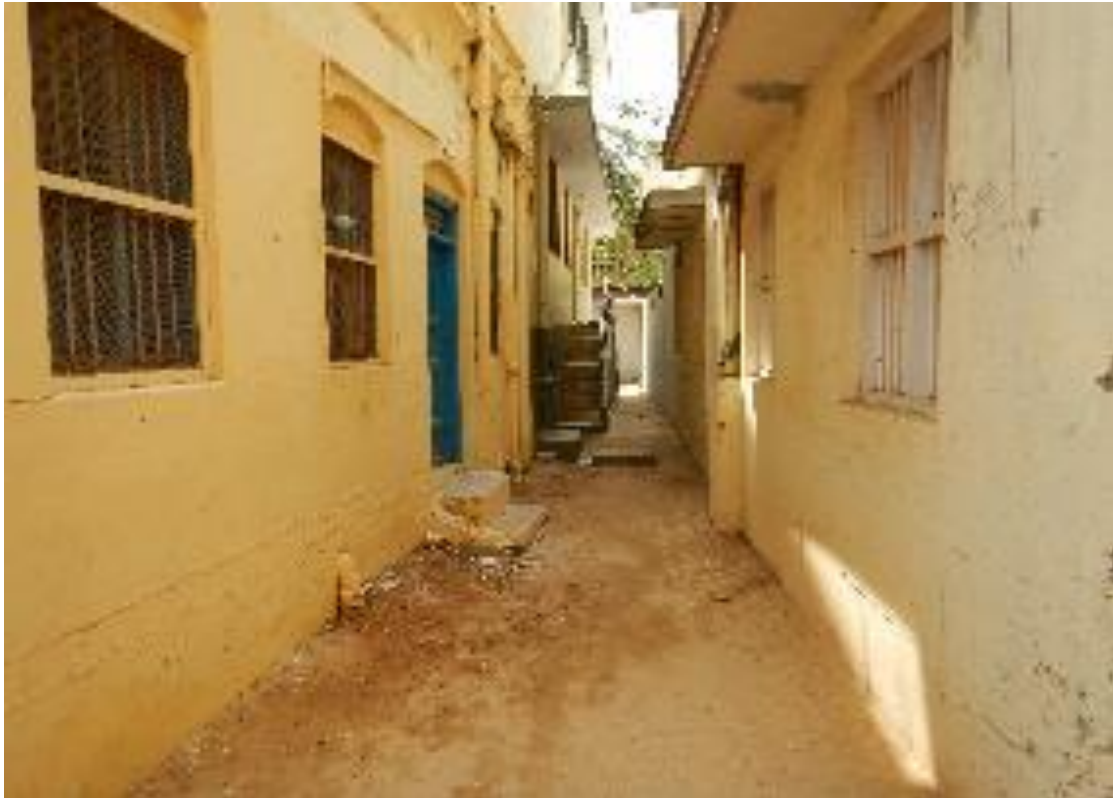
Figure 3.13: Narrow roads in Kilakarai

Informal discussions with households revealed that the practice of manual cleaning of pits is prevalent in most houses. Owing to the narrow inaccessible roads and high desludging cost, households hire local resources to clean the pits. Further interactions with pit cleaners divulged the manner in which the pits are cleaned and the contents emptied. Manual cleaning is usually done during the night time and requires three to four people. While one person gets into the pit using a rope, others assist in emptying the contents. Buckets are used to empty the contents which are then transferred to a large barrel. The sludge is disposed in open land or in the burial ground located in the outskirts of the town.

It was observed that in three-fourth of the households (74.9 per cent) the approach road was five to ten feet wide with sufficient space for a desludging truck to park. However, in 25 per cent of the households, the width of the nearest road to the containment system was less than five feet. Such narrow roads/lanes were observed in the old part of the town around the Sathakathullah Appa Dargha. The spatial growth pattern reveals a densely populated core town area around the Dargha with narrow lanes and tightly packed houses. This, being the old part of the town, has no open or adequate spaces for large vehicles to navigate or park.

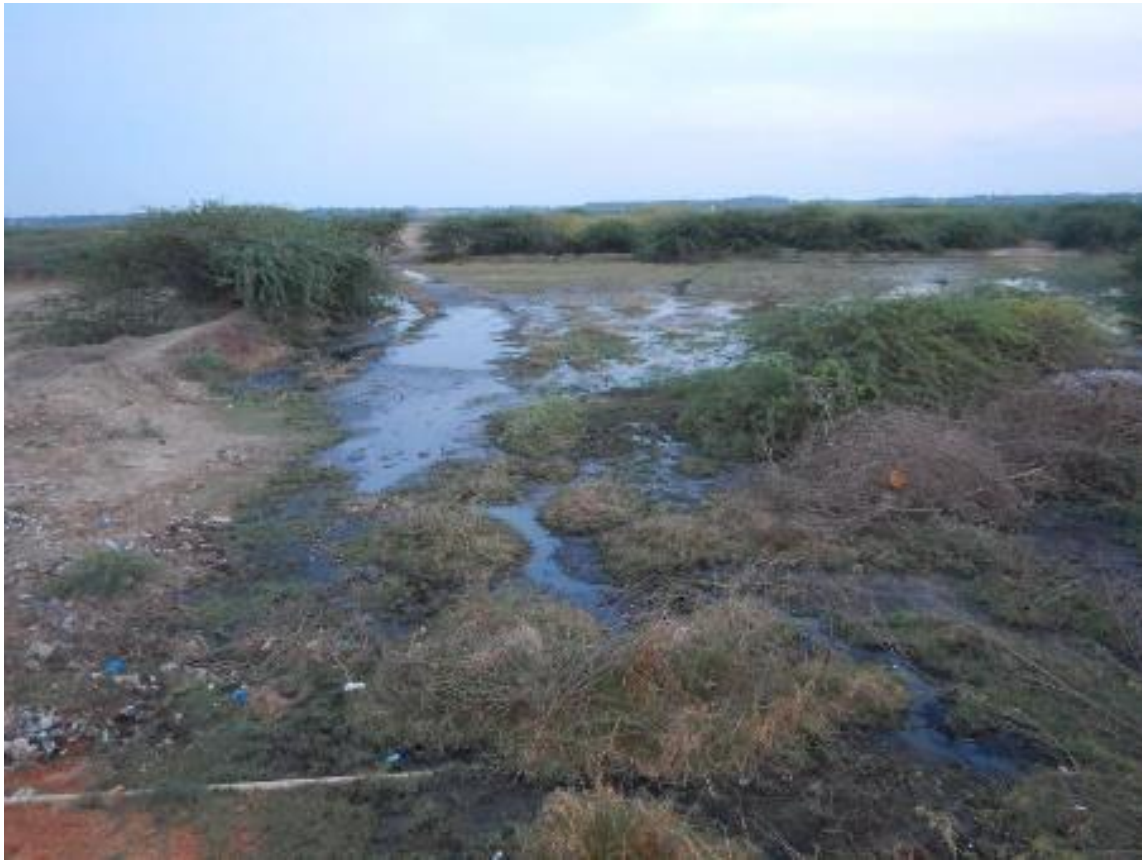
Figure 3.14: Fecal sludge disposed of in a vacant area

At present, there are no facilities available for septage treatment in Kilakarai. Informal discussions with private desludging operators indicate that the fecal sludge collected from residential and public/community toilets are disposed in a vacant area around 7 km from Ramanathapuram on the East Coast road.

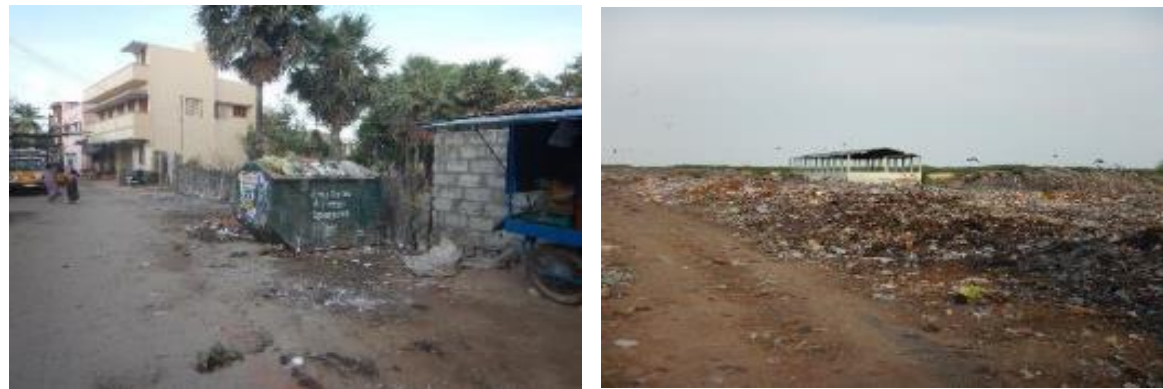
Figure 3.16: Solid waste management in Kilakarai

There are 25 permanent and 25 temporary sanitary workers posted for sweeping, cleaning and collection of solid waste. Streets are provided with bins that are regularly cleared by the sanitary workers. The solid waste generated from the city is taken to a dump yard (seven acres) that is 7 km from the city. It has been operative from the year 2012.¹³

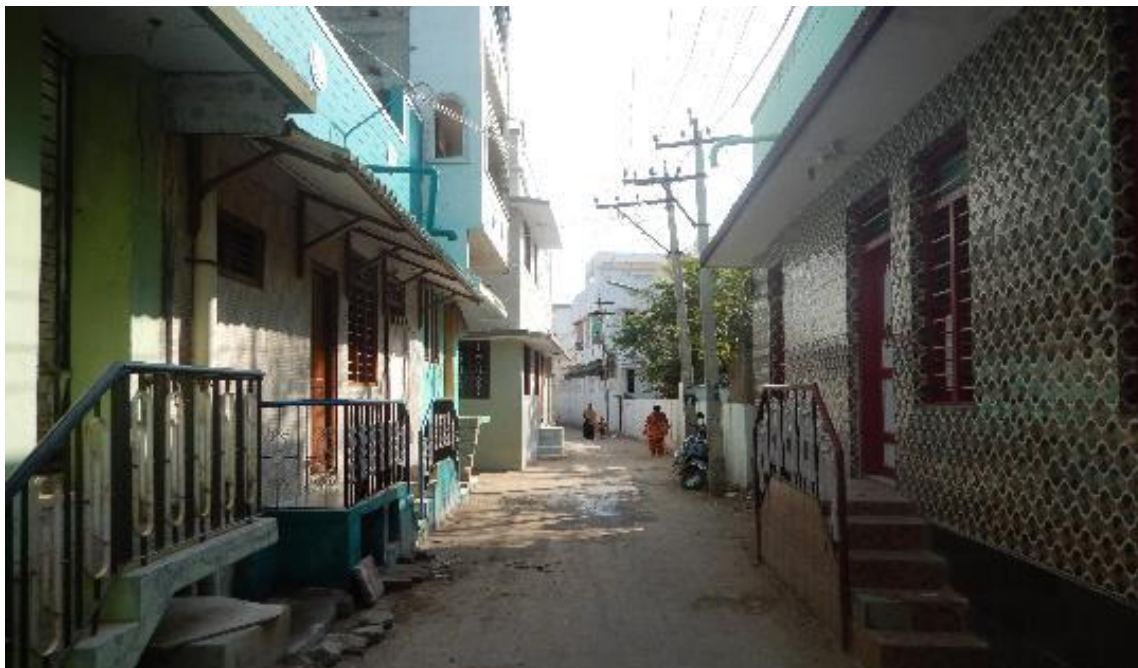
Figure 3.17: Absence of storm water drains

The total length of the storm drain is only 10 km. The town has kuccha open drains that covers 44 per cent of the total road length. The length of the open drains is about 78.25 km.¹²
