SFD Lite Report

Khordha India

This SFD Lite Report was prepared by
Centre for Advocacy and Research (CFAR)

Date of production/ last update: 24/02/2026

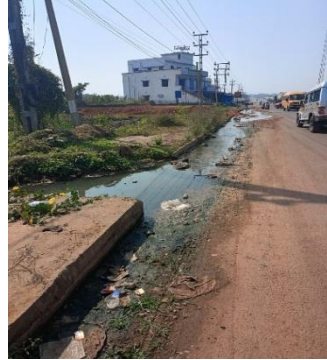
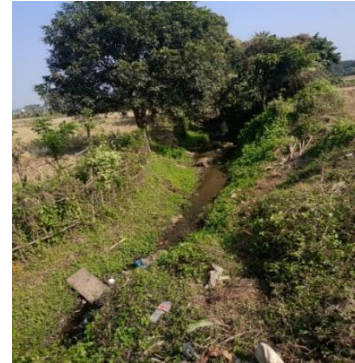
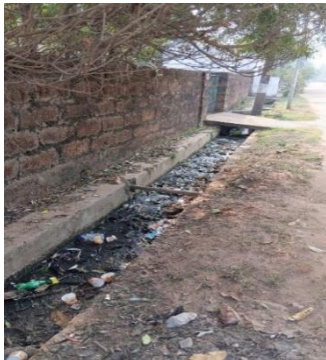
town's drainage infrastructure consists of five stormwater drains⁷ and two natural drainage channels, e.g. Chachera Canal and Jari Canal (KII-1, 2025)⁸. Household wastewater is conveyed through small lateral drains connected to the stormwater drains, resulting in the combined flow of stormwater and domestic wastewater being discharged into the natural drains. Downstream, these flows ultimately spread into agricultural lands and open areas.

The prevalent drainage system in Khordha is predominantly open in nature⁹, although certain stretches have covered drains. Field observations revealed that many covered drain sections are inadequately maintained, leading to blockages and reduced conveyance capacity¹⁰. During rainfall events, these blockages cause wastewater and stormwater to flow on the roads and public spaces, indicating poor operational performance of the drainage network.

Figure 1: a. uncleaned open drain; b. closed drain overflowing on the street due to blockages, c. open drainage to agricultural field (Source: Chinmayee, Bulton, CFAR. 2025).

To improve stormwater management, the municipality has recently prepared a Detailed Project Report (DPR) for drainage infrastructure. Its implementation is expected to begin shortly (KII-1, 2025)¹¹. An interview with the official from the Water Corporation of Odisha (WATCO), which

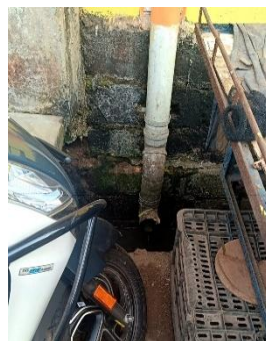
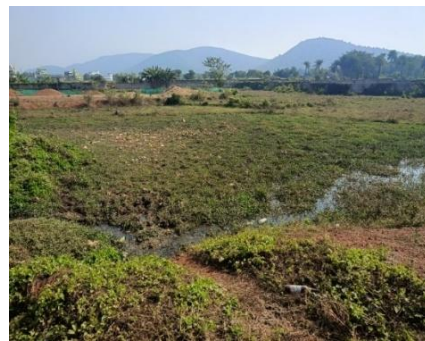
During the field survey, it was observed that in Ward No. 13, at Baseli Sahi, which is characterized by a compact and dense settlement pattern, space constraints have led to the absence of proper containment systems in several households. In such households, toilet outlets are directly connected to open drains, resulting in non-contained systems and unsafe discharge of faecal waste. Therefore, the T1A1C6 system was considered 4% of the total population of the town while generating the SFD graphic, which was also verified from the interview with the municipality official¹⁵.

Figure 2: Toilet outlet directly connected to an open rain, and drain water discharged into open grounds (Source: Soumyashree & Bulton, CFAR. 2025).

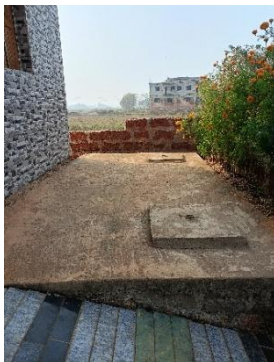
Out of the 89% of the population dependent on OSS, 13% have a properly built septic tank, and 26% have a fully lined tank (FLT). Both containment types are connected to a soak pits. Septic tanks and fully lined tanks are generally square or rectangular in shape, with average dimensions of 5-10 feet in length, 4-6 feet in width, and 8-10 feet (up to 12 feet) in depth¹⁶. Septic tanks are predominantly two-chambered.

Figure 3: a. Septic tank; b. outlet connected to soak pits; c. a fully lined tank with soak pit; d. FLT under construction. (Source: Bulton, CFAR. 2025).

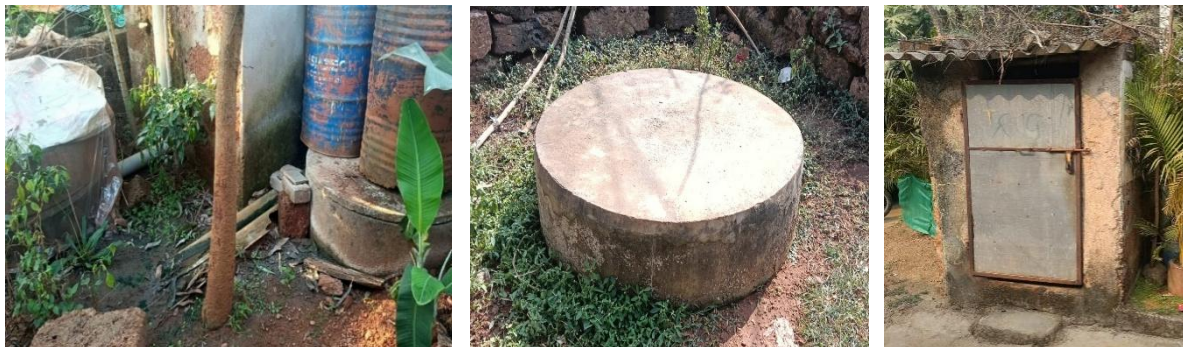
Another predominantly used containment system is lined tanks with semi-permeable walls and an open bottom with no outlet/overflow, used by 50% of the total population. These structures are either square and rectangular in shape, built with brick walls, or made up of circular rings, locally referred to as Nonda. Ring tanks are typically constructed using prefabricated concrete rings, stacked one over another with cemented joints. The average size of these tanks ranges from 3-4 feet in diameter and 3-8 feet in depth, extending up to 12 feet in some cases, with 6-8 rings commonly used depending on household requirements¹⁷.

Figure 4: Existing containment systems (Source: Chinmayee & Sunita, CFAR. 2025).

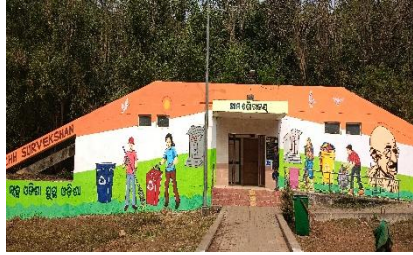
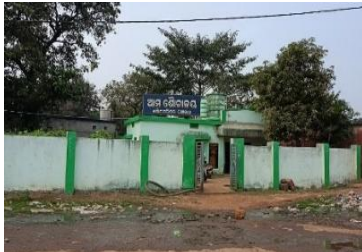
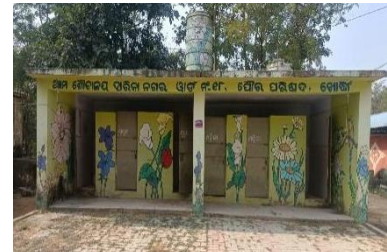
Public toilets are generally observed to be better maintained. However, limited water storage capacity often disrupts their regular functioning²⁴. In high-footfall areas, particularly near market zones and the bus stand, waterlogging was observed at the entrance of the public toilets.

Figure 5: a. water accumulated in front of PT, ward no. 11; b. Well-maintained PT at ward no. 5; c.

Leakages in the containment, CT, ward no 8. (Source: Bulton, CFAR. 2025).

Open urination outside the premises of public toilets was also noted. In the case of community toilets, overflow from containment systems and visible seepage were observed during the field survey. The toilet caretakers reported that emergency desludging is occasionally required due to these recurring overflow issues, which they previously carried out by themselves manually, followed by disposal of sludge in adjacent low-lying land (KII-5, 2025)²⁵.

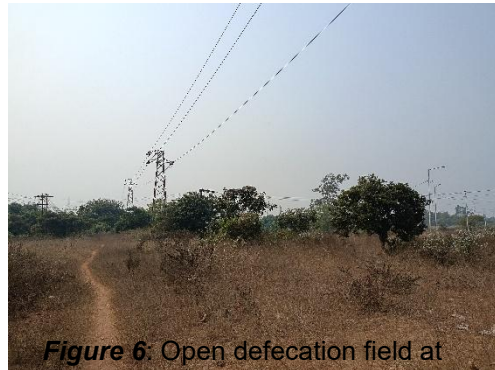
Although Khordha town has been declared ODF, the household survey revealed continued open defecation in select slum clusters, particularly in Wards 2, 6, 9, 10, and 11, mainly among poor and low-income households lacking individual toilet facilities. Key drivers include affordability constraints, limited subsidy support, non-availability of nearby public toilets, and strong behavioural factors, with safe sanitation often deprioritized. The practice of open defecation has also been acknowledged by the municipal officials²⁶. Hence, based on triangulation of household survey findings, KIIs with officials and desludgers, and SBM-IHHL data and the 2011 census open defecation figures, the prevalence of open defecation was calculated at 7%.

Figure 6: Open defecation field at Bhalibadi Sahar Sahiward no. 10. (Source: Bulton. CFAR. 2025).

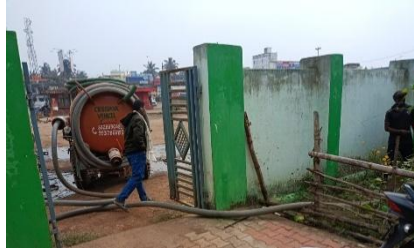
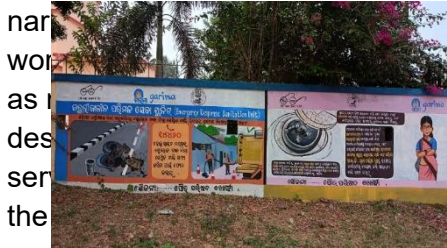
The cesspool vehicles are equipped with mechanised pumps, storage tanks, and hoses extending up to 200 metres to facilitate desludging in households in congested areas with

Desludging operation is typically carried out by a team of three workers and two helpers. Personal protective equipment (PPE), such as gloves and boots, is used as a safety measure during operations. On average, the desludging process takes 30 minutes and 1 hour per containment system. These services are generally delivered on a demand basis. Households place desludging requests through the services are generally delivered within three days.

Figure 7: a. IEC promoting safe sanitation & workers' safety at FSTP wall; b. cesspool vehicle emptying PT containment; c. Advertisement of Private Desludging Service Operators (Source: Bulton, Soumyashree, CFAR. 2025).

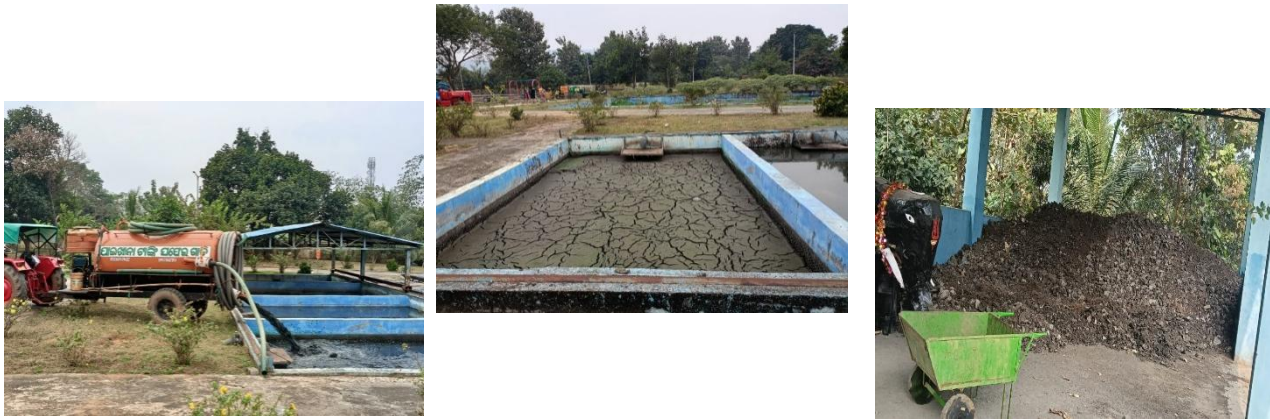
At present, Khordha town does not have a wastewater treatment plant. However, for faecal sludge treatment, the town is served by a designated FSTP with a capacity of 20 KLD. The FSTP is located at Bibha Vihar, Ward No. 1, and is operated and managed by the Trinath Dakua Self-Help Group. The plant is based on anaerobic treatment technology and is reported to be operating at full capacity, receiving approximately 4 to 5 cesspool vehicles per day (KII-3, 2025)³².

Figure 8: a. Cesspool vehicle unloading septage at the FSTP, b. treated sludge over the drying chamber, c. stockpiled bio-solid (Source: Bulton, Labanya. CFAR. 2025).

The treated effluent (blackwater) from the FSTP is reused for plantation within the plant premises. The treated sludge is utilized for non-food crop cultivation and, in some instances, for landscaping purposes in municipal parks. The treated outputs are not used for any commercial agricultural purposes.

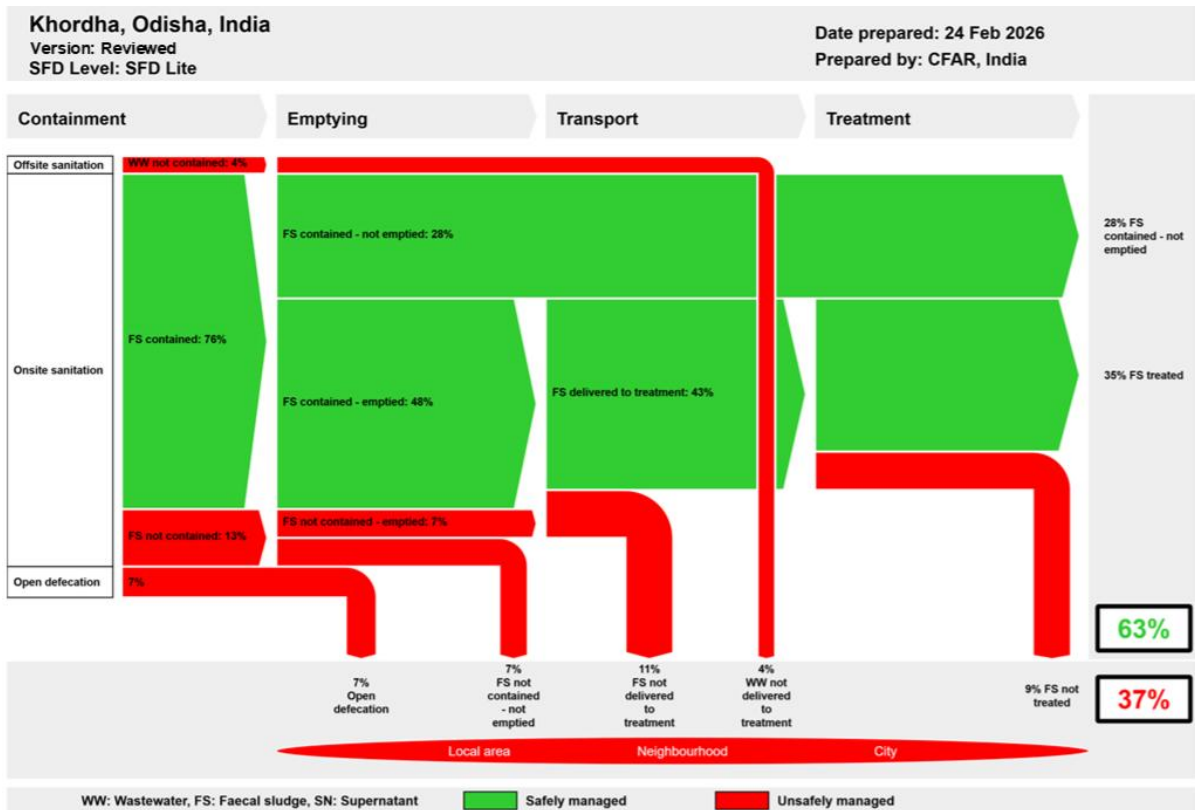
Figure 9: SFD Graphic for Khordha.

The outcome of the SFD graphic shows that 63% of the excreta flow is classified as 'Safely Managed' while 37% of all excreta flow is classified as 'Unsafely Managed' (see SFD graphic). The unsafely managed excreta originates from Faecal Sludge (FS) not delivered to the

treatment plant (11%), Wastewater (WW) not delivered to treatment (4%), FS not contained-not emptied (7%), FS not treated (9%) and Open defecation (7%).

The safely managed excreta originate from FS that is contained and not emptied (28%), and FS treated (35%). However, the safely managed FS generated by this 28% of the population is temporary since FS from their onsite sanitation systems will require emptying services in the short and medium term as they fill up.
